W. Charles Perry & Associates

Re: Mora vs. Case International Harvester, et al.

I apologize for the delay in sending this preliminary investigation report. To briefly summarize my work through today's date, I have performed the following tasks:

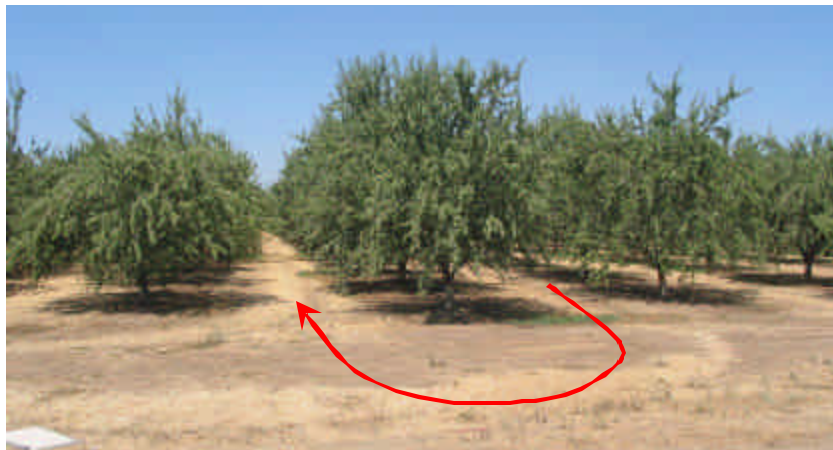
As I understand the sequence of events leading to Mr. Mora's injury, he was mowing the grass between the rows of the incident orchard. After mowing one row in an eastward direction, Mr. Mora made a U-turn onto the next row to the south – the incident row – and began to mow in a westward direction (see the following photograph):

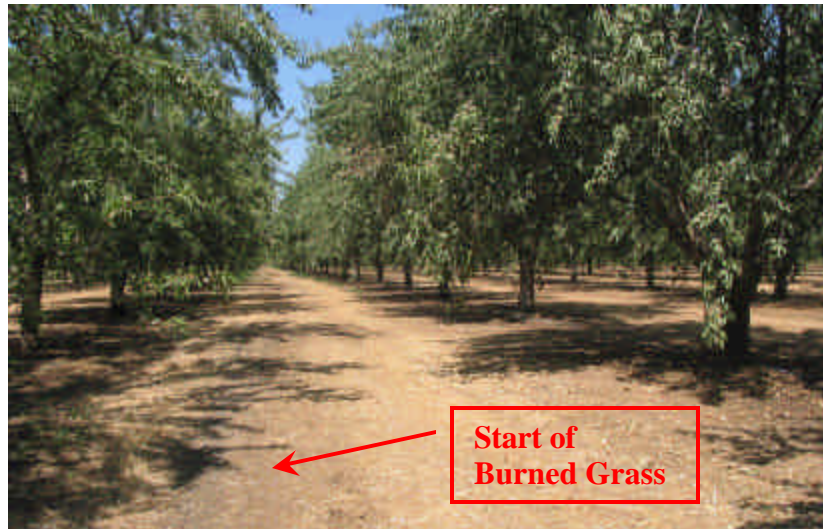
After mowing roughly 800 feet, a fire started on the rear of tractor that Mr. Mora was driving. The following photograph shows the start of the burn pattern on the incident row:

Based on my inspection of the incident location, the fire was clearly on the mower: tree branches were wilted even though grass was short; the burn pattern was discontinuous in the grass; and fire spread north from the wreck location even though there was no evidence of fire between the incident tree row and the wreck location. I took one sample of grass to test for the presence of hydrocarbons such as diesel fuel, motor oil, or hydraulic fluid.

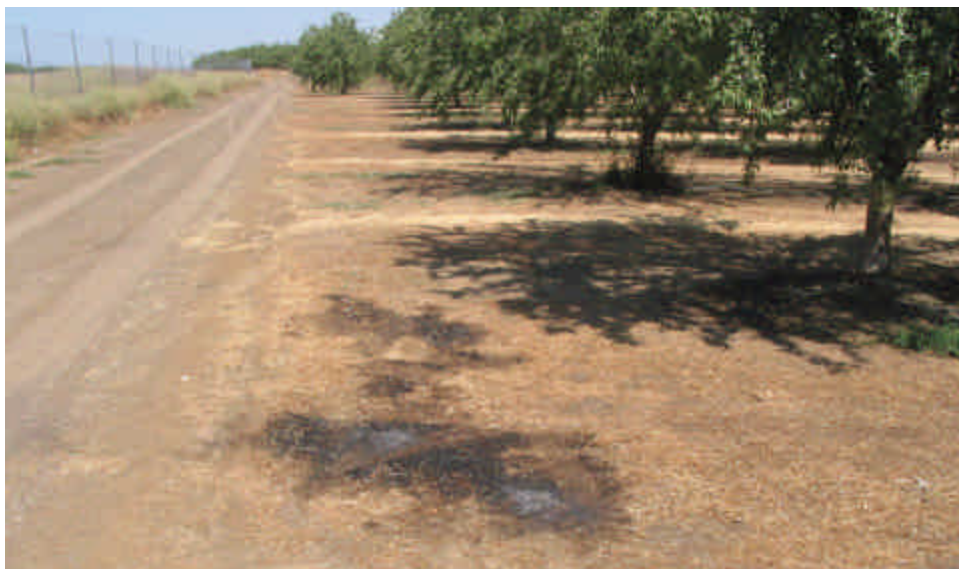
Mr. Mora raised the mower and increased his speed in the hope of driving to the water tower at the northwest corner of the orchard and extinguishing the fire; Mr. Mora did not disengage the power take-off from the tractor to the mower; the mower blades continued to turn as Mr. Mora drove. Mr. Mora drove roughly 1200 feet to the end of the row he had been mowing, and turned northwestward on the dirt road adjacent to the water canal. The view of the road and canal from the end of the row is shown in the following photograph:

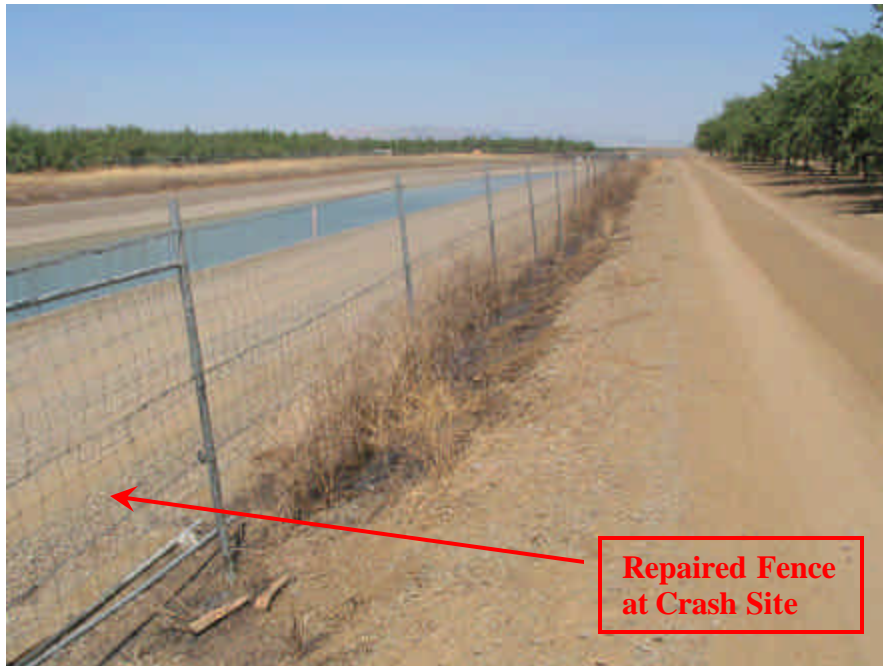
Mr. Mora drove the tractor another roughly 1400 feet until he was thrown from the tractor (he was driving quickly and was standing to avoid the flames); the tractor drove off the road, through the fence, and into the canal. In the process of wrecking itself, the mower passed over Mr. Mora's body and cut off one of his legs and castrated him.

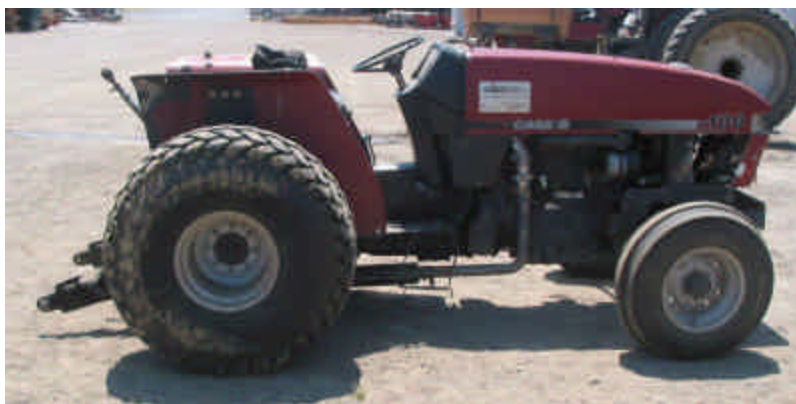
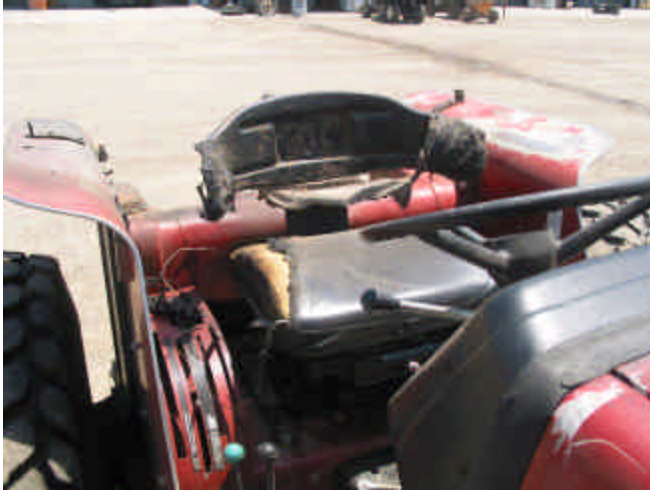
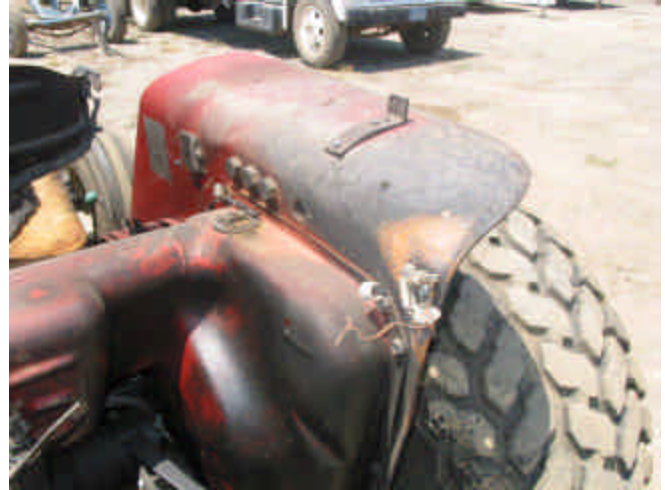
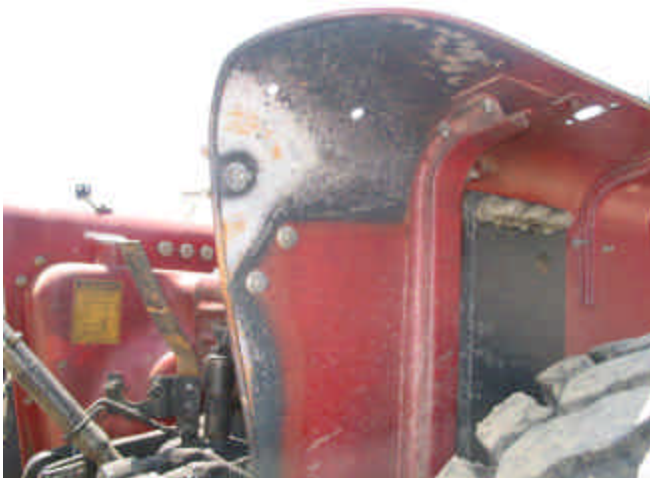
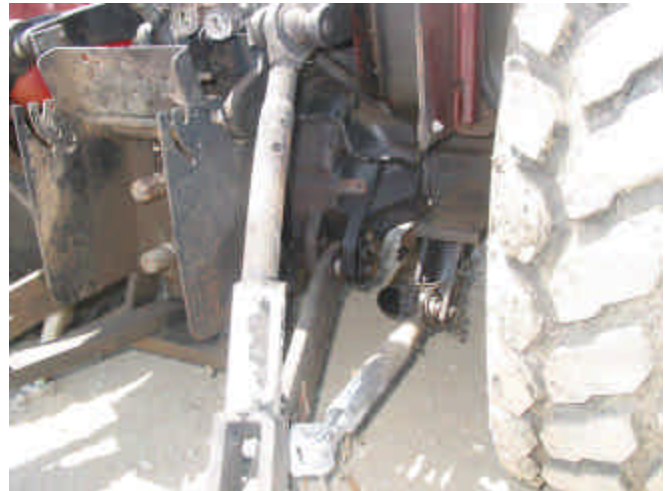
Fire damage was visible on the right rear of the mower – up to and including the driver's seat, thus reinforcing Mr. Mora's claim that he was standing as he drove the tractor. This is shown in the following photographs:

Based on these photographs, the fire appears to have been primarily on the front of the mower to the right side of the drive shaft and secondarily on the tractor on right lift arm, the right fender, and right side of the seat.

Based on my inspection of the mower, it had a transmission (or power transfer case) on its top. Customarily, these are partially filled with gear oil and are not pressurized. Any leakage tends to be slow and limited to less than 1 quart of fluid. A quick review of the preceding photographs of the tractor shows what appears to be a thin coating hydraulic fluid on the right side of the rear of the tractor. Based on these observations, the source of fuel for the fire appears to be a hydraulic fluid leak that was spraying fluid towards and on the mower. However, given the preliminary nature of the investigation, this should be treated as a working hypothesis to be tested further.

1. Test the grass sample from the field for the presence and identity of combustible fluid.
2. Inspect & disassemble the mower transfer housing / transmission to locate any leaks.
3. Inspect & disassemble the tractor to locate any leaks in the hydraulic system, fuel system, transmission, or engine.

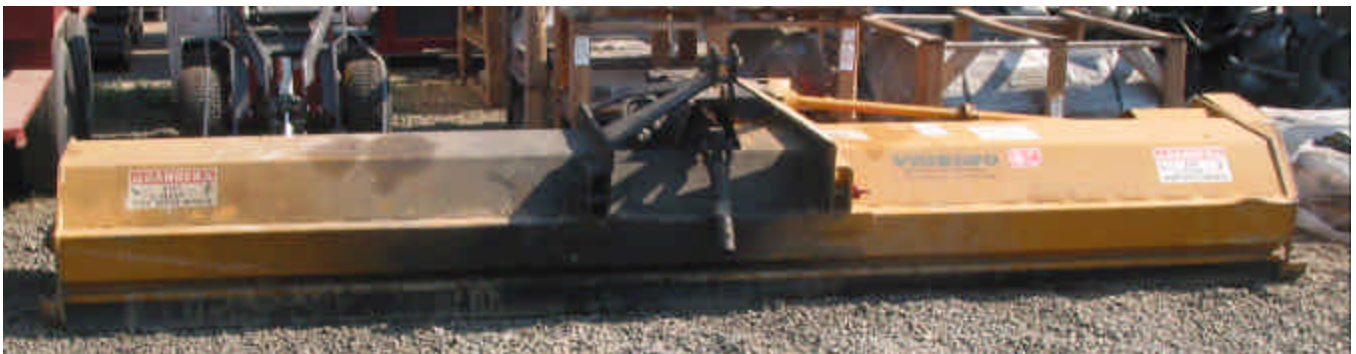
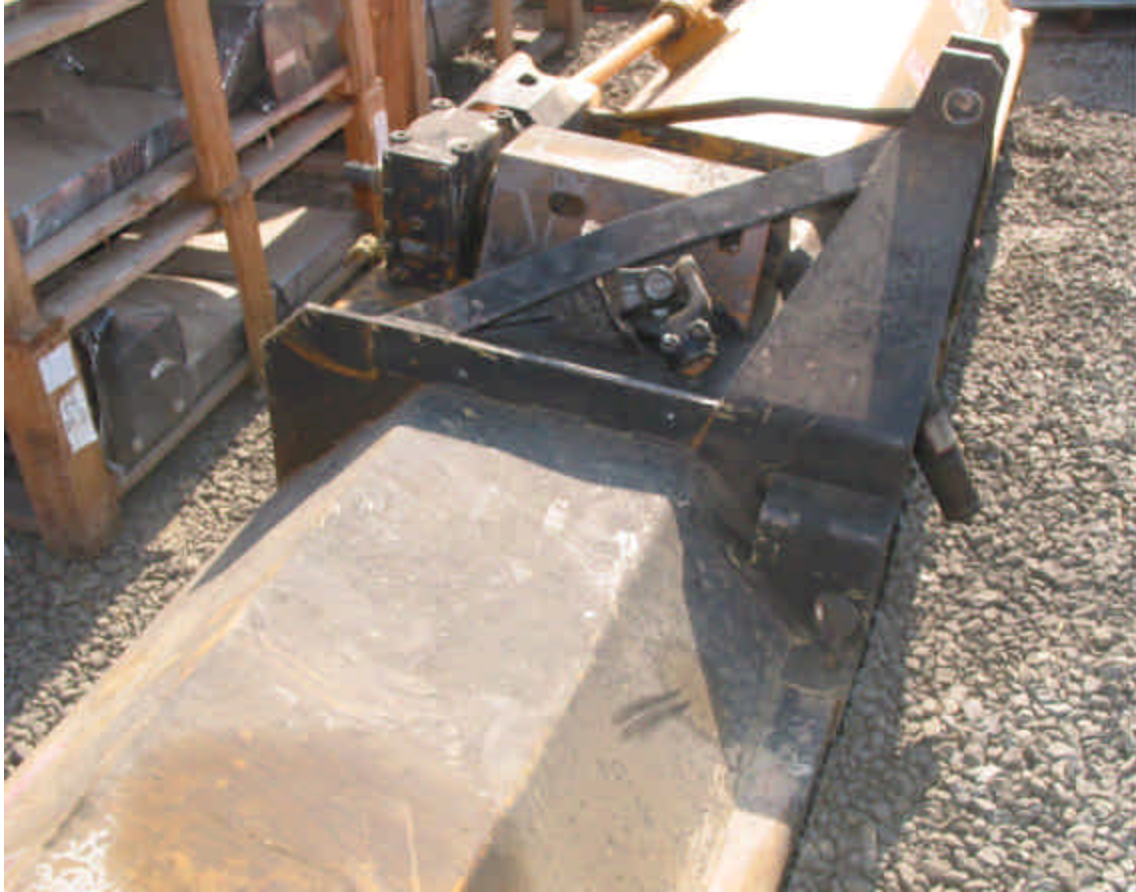
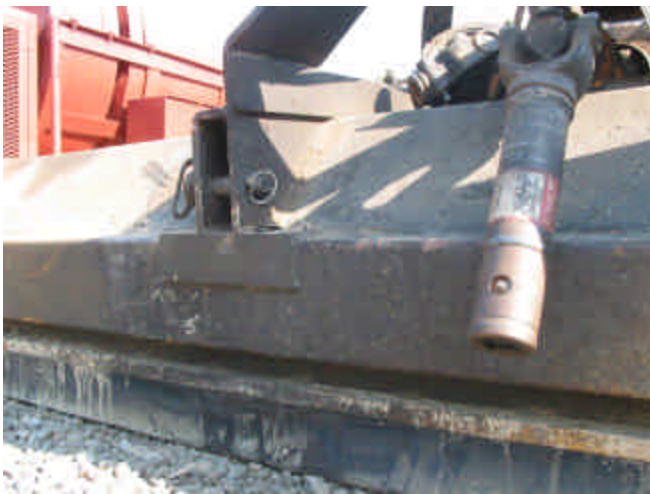
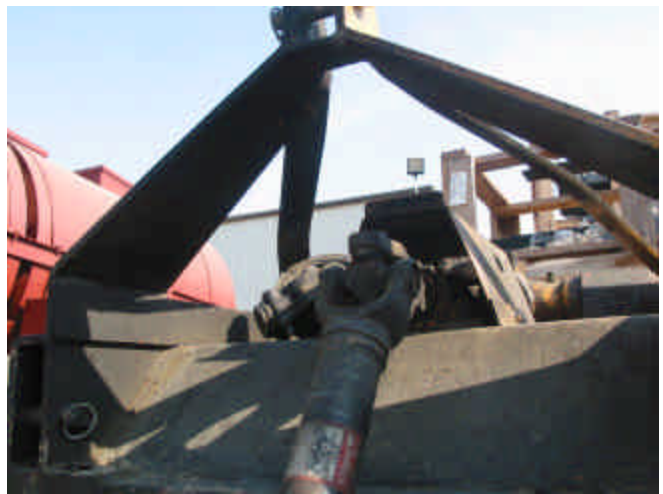
Fire damage was shown on the corresponding side of the mower. This is shown in the following photographs:
