Re: California Hydronics vs. Kirkwood Mountain Utilities

Please accept this letter as a response to your request for a report on my testing & inspection of the Fisher regulator involved in the explosion at Kirkwood Mountain Utilities that is the basis for the referenced litigation. Not knowing the condition of the regulator settings, on November 11th of 2002, I initially tested the regulator with 250 psi gages. These gages lacked the sensitivity to accurately measure the low pressure setting of the regulator. On November 12th of 2002 I then switched these gages for a 60 psi gage on the inlet side and a 30 psi gage on the outlet side. I did not connect the downstream control line connection because I did not know if it was connected at the time of the incident and I did not want to alter the condition of the regulator in any way. The test setup I used is shown in the following photograph.

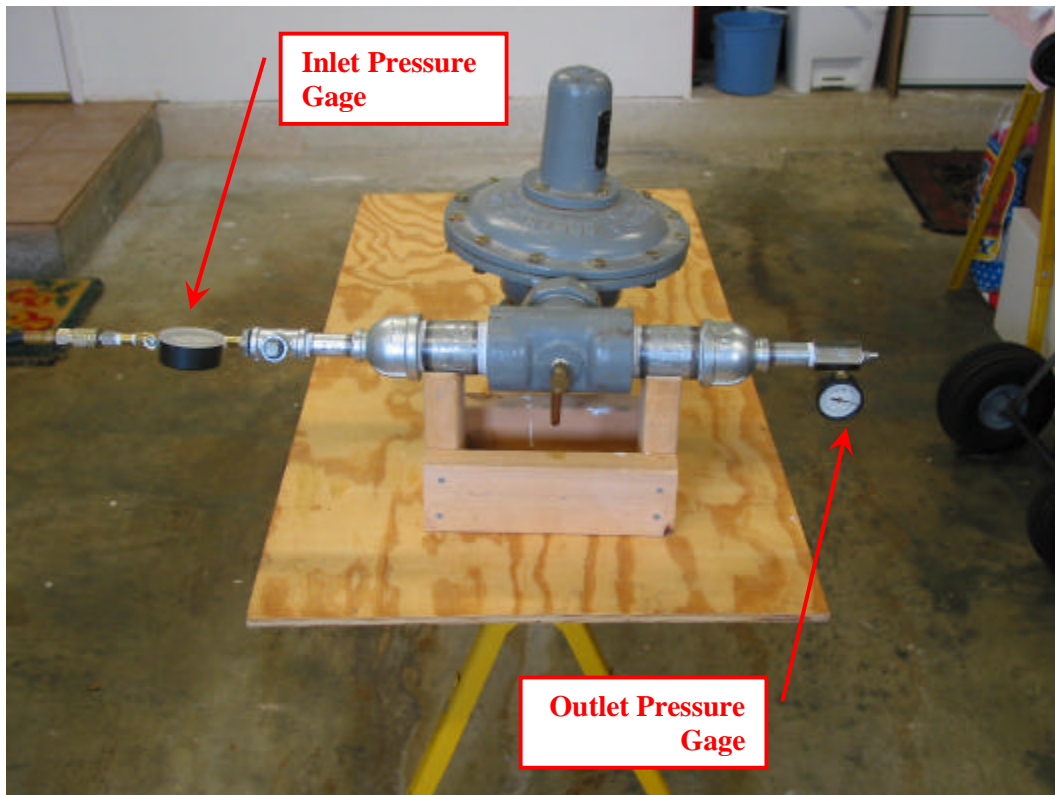
At 14 psi inlet pressure the outlet pressure was 6.5 psi. At 38 psi inlet pressure, the outlet pressure was 7.0 psi. Under both test conditions the outlet pressure gage fluctuated between 4 and 7 psi initially and then stabilized. Digital movies of the operation of the regulator during these tests are shown on the CD that I sent to you (see files "100-0067_MVI – Variation in Outlet Pressure" and "100-0071_MVI – Variation in Outlet Pressure - Test 5"). These files can be viewed with Windows Media Player or similar digital media software on your computer.

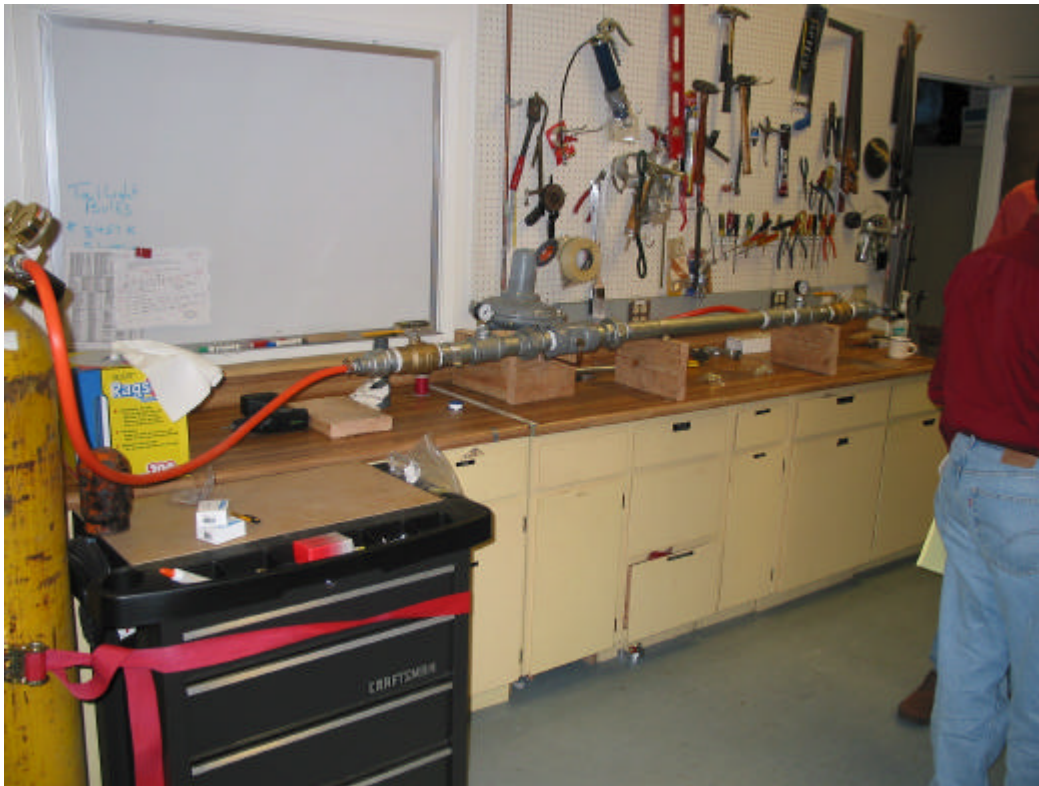
On January 14th of 2003, I monitored the testing of an exemplar regulator as well as the incident regulator at Aptech Engineering, Inc., 1253 Reamwood Ave., Sunnyvale, CA. The test setup for the incident regulator at Aptech is shown in the following photograph:

The initial test setup had a downstream control line connecting the regulator to the outlet pipe. For inlet pressures between 25 psi and 125 psi the outlet pressure was steady at an average value of 4 ½ psi for flow rates from 0 cfh (cubic feet per hour) to 600 cfh. When the downstream control line was removed and the inlet pressure held constant at 100 psi, the outlet pressure peaked at 12 psi and then dropped to a steady 4 ½ psi at 0 cfh. When gas flow was started, the outlet pressure cycled between 2 psi and 6 ½ psi and the flow rate cycled between 50 cfh and 125 cfh. As the gas flow was increased, the outlet pressure cycled between 0 psi and 8 psi and the flow rate cycled between 50 cfh and 500 cfh. A digital movie of the cyclical flow rate and pressure caused by the disconnected downstream control line is shown on the enclosed CD (see the file entitled "MVI_0091 – No

Downstream Control Line Test”). When the gas flow was stopped at the end of testing without the downstream control line, the pressure peaked at 11 psi and dropped slowly to 5 psi.

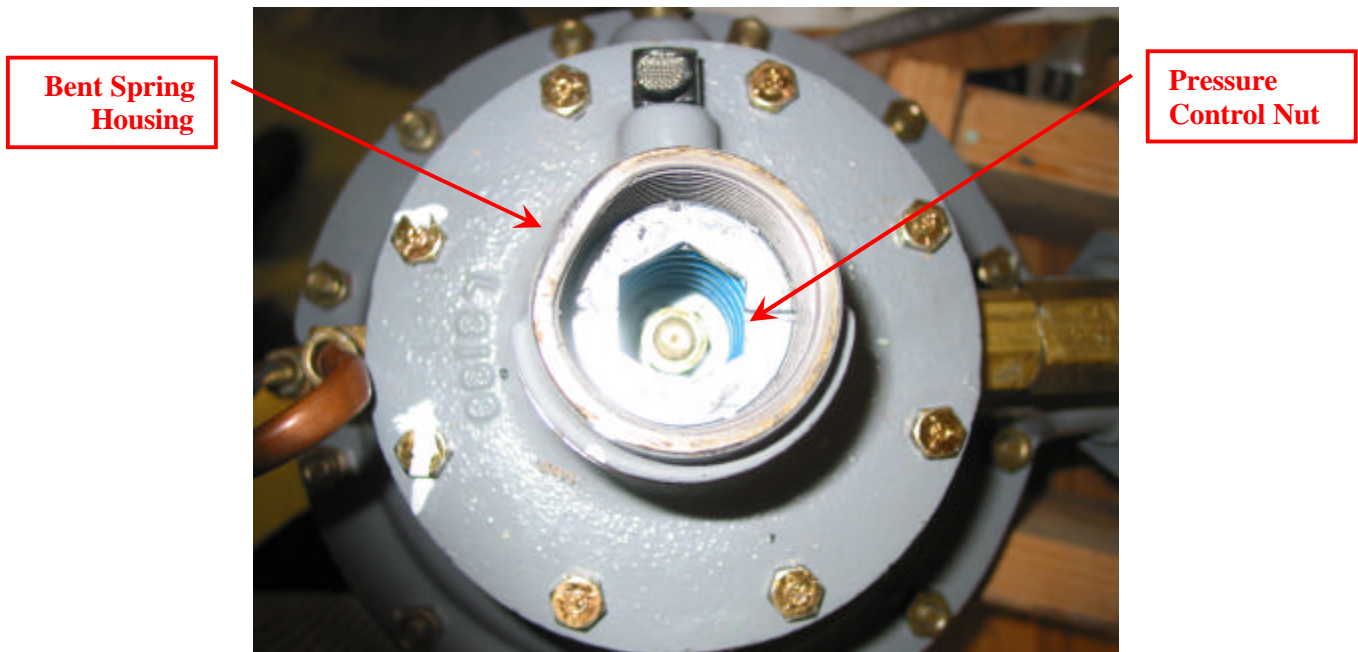
Finally, the exemplar regulator’s pressure control spring housing was damaged between the time I tested the regulator on November 11th of 2002 and the time it was tested at Aptech on January 14th of 2003. It appeared to have been damaged during shipping. This damage did not appear to affect the operation of the regulator in any way. This damage is shown in the following photograph:

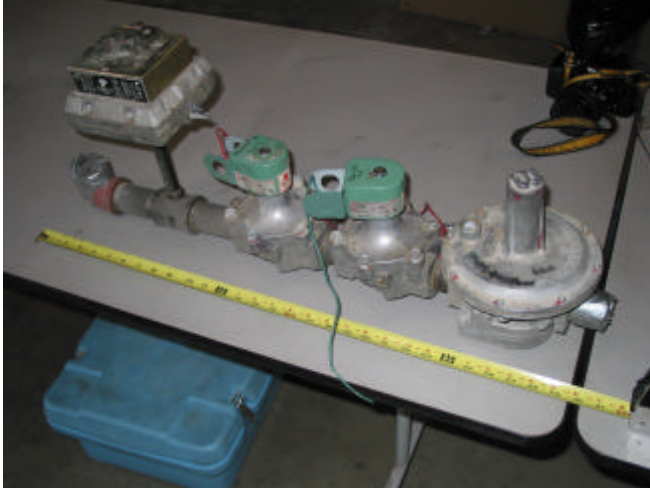
Burner Gas-Control Valve Train

On January 16th of 2003 I inspected components of the exhaust flue, the gas-control valve train for the burner, and the gas-control valve train for the pilot attached to the incident boiler at California Hydronics, 2293 Tripaldi Way, Hayward, CA. Details of the individual components are shown in photographs on the enclosed CD. Both valve trains are downstream from the Fisher regulator and upstream from the incident boiler, and the actual explosion occurred in the flue which is downstream from the boiler. No testing of these components was allowed during this inspection. A general overview of these components are shown in the following photographs.
